CLEANROOM VALIDATION

The Guardtech Group Service Department were tasked with conducting a full Validation on an ISO8 cleanroom, including testing of: Air Change Rates, Pressure Differen-

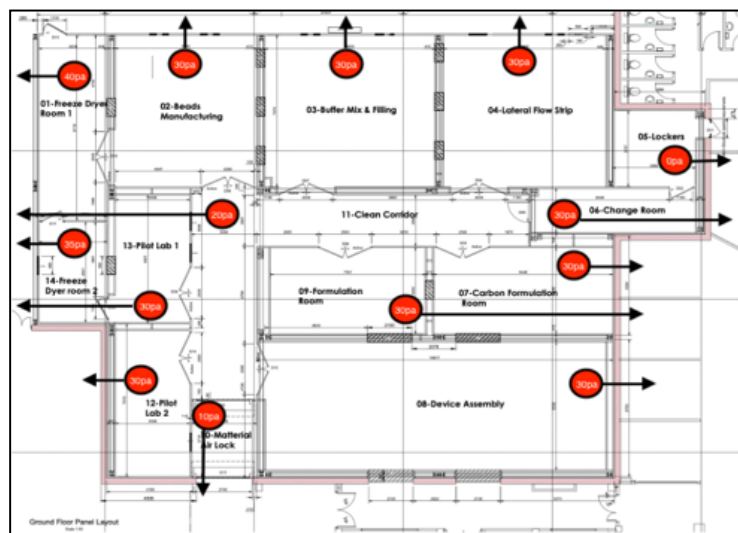
Figure 5 – Pressure Measurement Locations GF (plan view)

Pressure Differential Testing: Using a Calibrated Pressure Gauge, the Guardtech team measured the Pressure Differential in the specified zones shown on the diagram (right) by running a tube between the rooms. Each reading was then recorded once a steady result was obtained. All relevant equipment and plant associated with the cleanroom, such as the Air Handling Unit and extract systems, had to be operational, while

all relevant doors were closed. The recorded Pressure Differentials satisfied the requirements set out in our results table and a pass was recorded.

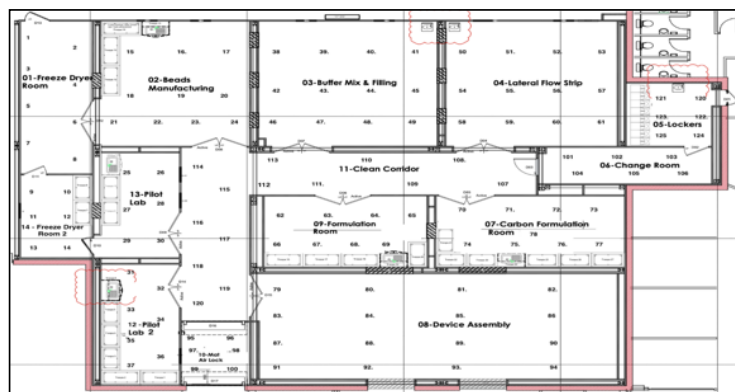
Figure 13 – Particulate count monitoring positions at bench height GF (plan view)

Particulate Count Measurement: With the rooms At Rest, the Validation Engineers carried out particle counts in the cleanroom at bench height. The Occupancy State is determined in accordance with ISO 14644-1:2015 section 3.3. The number of locations tested was determined by ISO 14644-1:2015 and was situated as marked out in the diagram (*below*) in accordance with ISO14644-1:2015 Annex 4.3. Each location was sampled for one minute in accordance with ISO 14644-1:2015 Annex 4.4. Engineers set the flow rate to 50 Lmin⁻¹ and the units of measurement set to m3. The particle counter was set

to measure for 0.5 and 5µm-sized particulate. The highest recorded particulate counts were recorded in the test results table, where a pass or fail would thus be determined against the Grade/Class determined in accordance with ISO14644-1:2015 section 4.3. Later, the Complete Raw Data was appended, detailing all test location results. Each reading from all locations was below the maximum permissible value for the Classification as stated in the results table and so the test was deemed to have been passed.

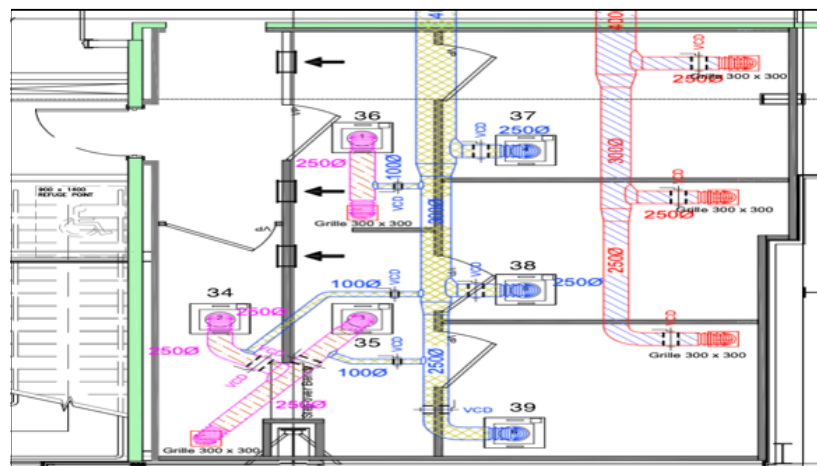
Figure 19 – Humidity Monitoring positions at bench height GF (plan view)

Humidity Levels: The humidity was measured at a minimum of one location for each humidity-controlled zone

(below). Each sensor was placed at the designated location at work-level height using a calibrated humidity sensor. After sufficient time was allowed for the sensor to stabilise, the humidity reading at each location was recorded. Measurements were performed as appropriate for the purpose of the application and the measurement time was at least five minutes, with one value recorded at least every minute. The average reading from each room was above the minimum permissible humidity value and so the cleanroom was deemed to have passed.

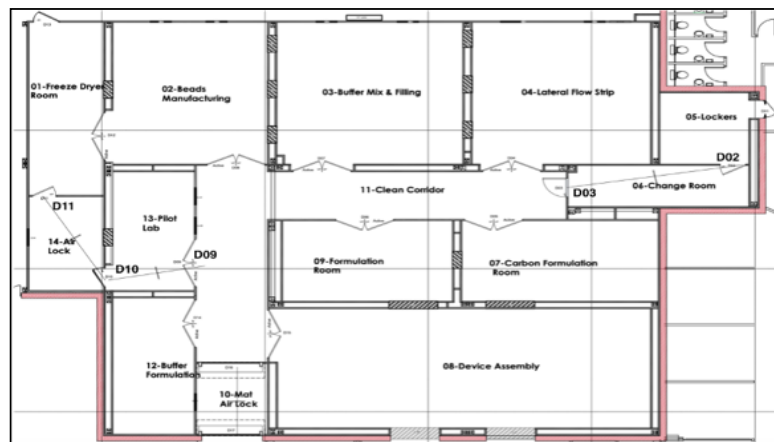
Figure 21 – Door Interlock Schedule Drawing GF (plan view)

Door Interlock Testing: The Guardtech team were tasked with ensuring all interlocked room doors were fully operational (*below*). Using our Matrix result tables, Engineers were required to open each door, and check the other referenced interlocked door to ensure the interlock has engaged.

The process was then repeated for all remaining interlocked doors. With the Door Under Test 'open', the Interlocked Door had to interlock/not open. All doors operated correctly and the test was deemed a pass.
